PB92-916501
NTSB/PAR-92/01

PIPELINE ACCIDENT REPORT

NATURAL GAS EXPLOSION AND FIRE
DEPARTMENT OF DEFENSE/ARMY
FORT BENJAMIN HARRISON
INDIANAPOLIS, INDIANA
DECEMBER 9, 1990

ADOPTED: APRIL 8, 1992

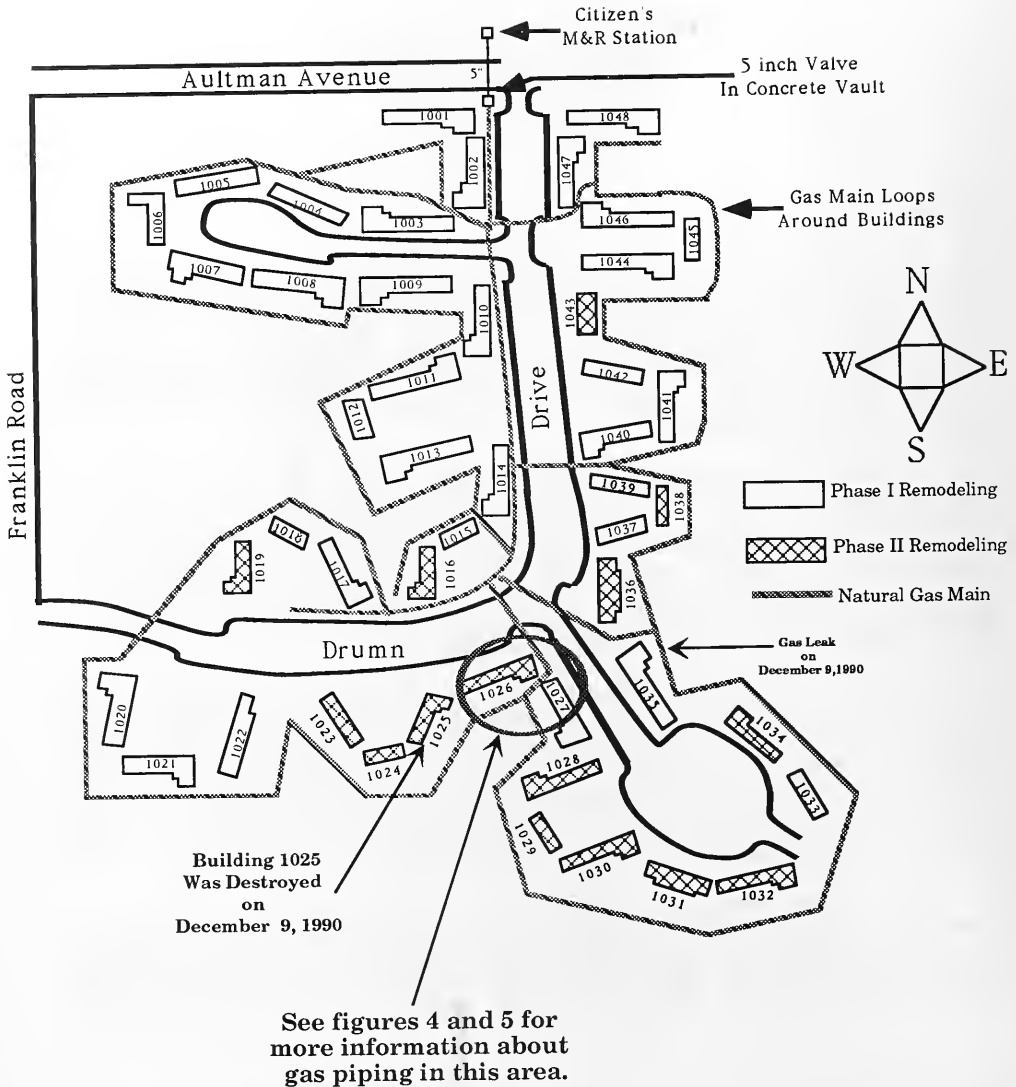
At 5:42 p.m. on December 9, 1990, an occupant of Harrison Village¹ (village), a residential housing complex within the Army's Fort Benjamin Harrison (Fort) near Indianapolis, Indiana, telephoned the Fort's fire department to report the odor of natural gas behind apartment 1035 B on Drumn Drive. (See figure 1.) The Fort's fire department dispatched firefighters, including the assistant fire chief, who served as the incident commander. They arrived at 5:47 p.m. and using a combustible gas indicator, confirmed the presence of gas both outside and inside some of the five apartments in building 1035.

Figure 1.--Schematic of Harrison Village, Fort Benjamin Harrison.
